UH-1 ACCIDENT SUMMARY

THE U.S. ARMY BOARD FOR AVIATION ACCIDENT RESEARCH - FORT RUCKER, ALABAMA

1 July 1966 through 30 June 1967

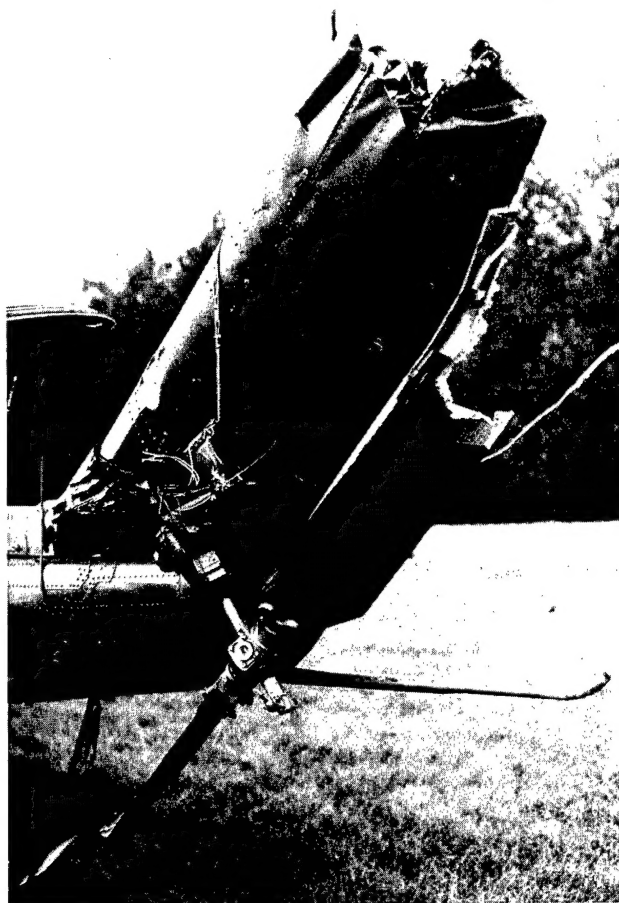
G481—While hovering from parking zone at night, aircraft drifted right and tail rotor blades hit main rotor blades of parked aircraft. Caused by loss of orientation and by preoccupation of copilot due to tuning radios and attempting to correct an inoperative instrument light.

G481 - Copilot was preoccupied and tail rotor blade struck parked aircraft.

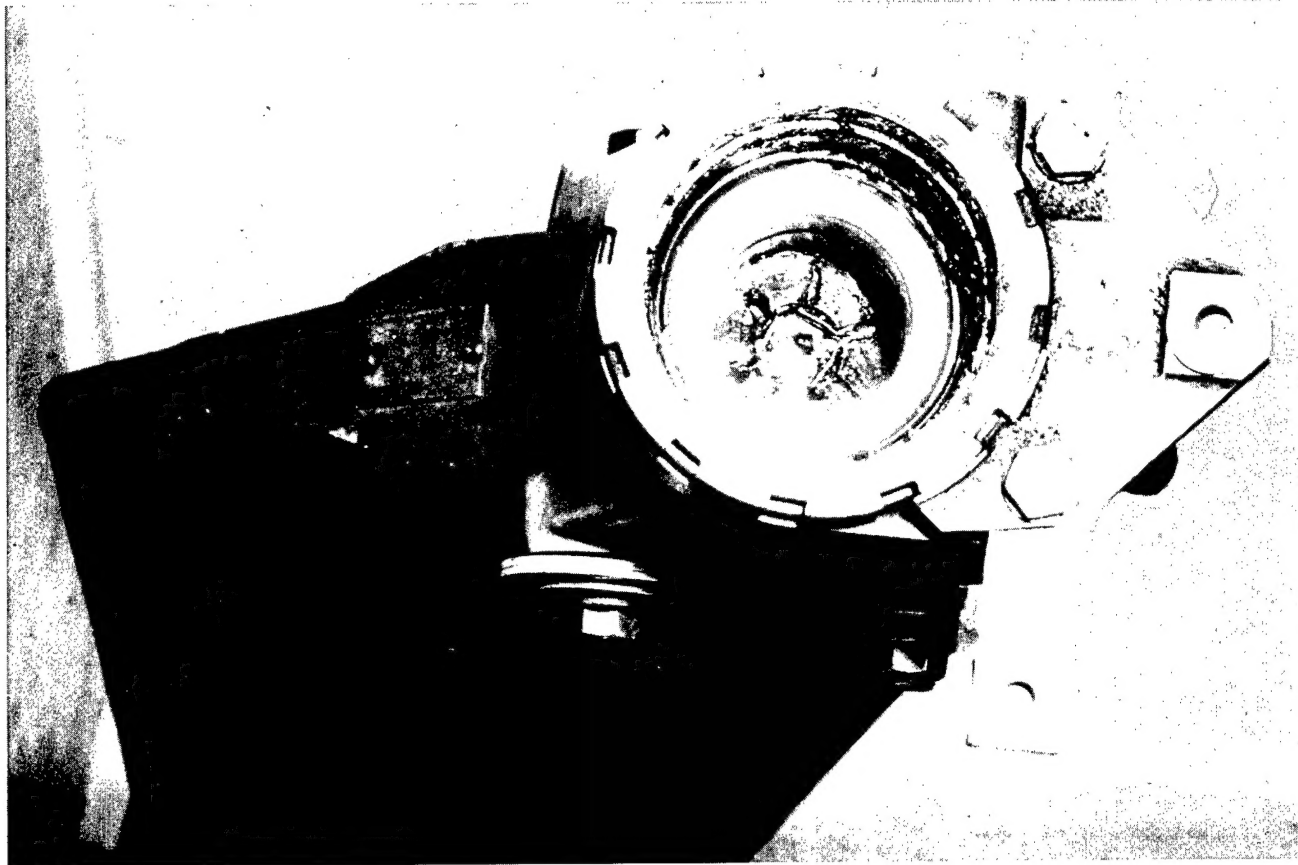
H813 - Tail rotor yoke failed because retaining nut was improperly torqued.

H813—Pilot heard loud explosive noise during hover to takeoff pad for maintenance test flight. Aircraft vibrated and turned to the right. Power was reduced and aircraft landed hard on left skid. Tail rotor and gearbox separated from pylon, and tail boom was severed by main rotor blade. Caused by failure of tail rotor yoke due to loss of retaining nut torque.

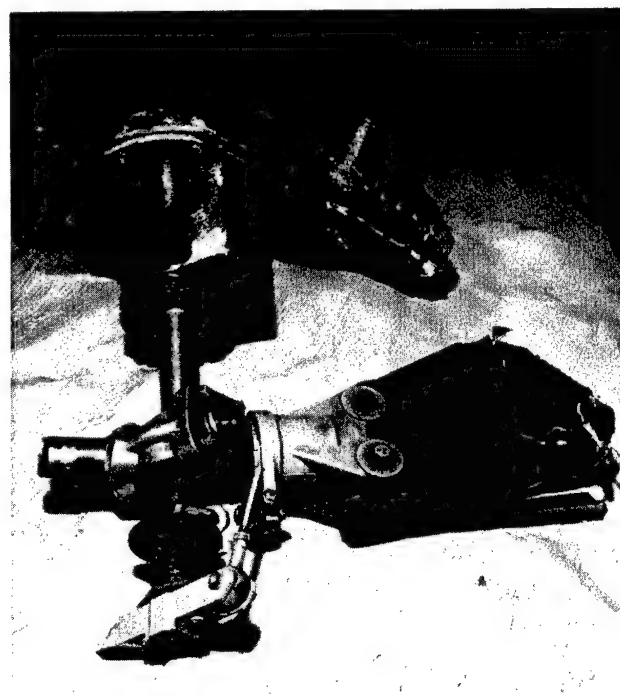
050512 - Severed threaded area of yoke arm caused by failure of tail rotor hub assembly.
